**NBSIR 73-299**

# **Examination of Failed Eight Inch Welded Steel Pipe Natural Gas Main, UGI Corp., Coopersburg, Pennsylvania**

Failure Analysis Report

Prepared for  
Office of Pipeline Safety  
Department of Transportation  
Washington, D. C. 20590

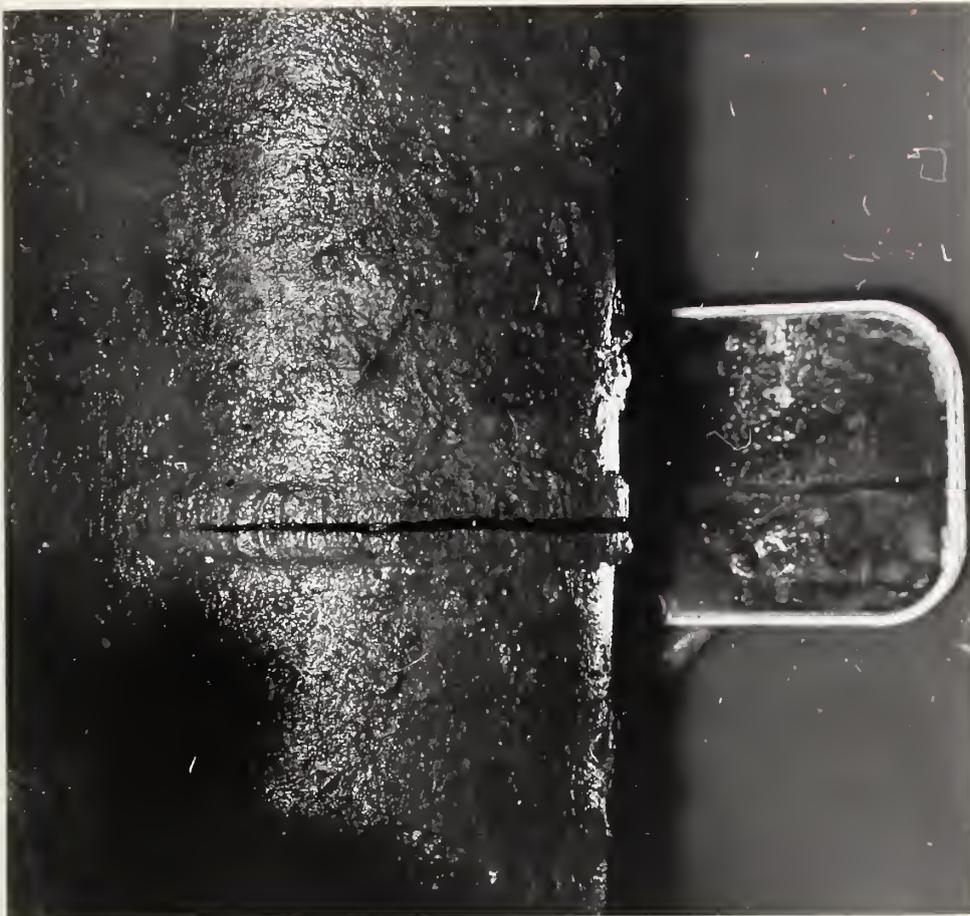
The outside wall surface of the pipe length was covered with a heavy scale (corrosion product). There were areas that were also covered with what appeared to be tightly adhering soil. The top of the pipe appeared to have less scale and fewer soil deposits than the rest of the pipe. According to OPS, the bolts holding the clamp on the pipe were at the top of the pipe. The clamp is shown in place in figure 2. The letter "T" in figure 4a indicates this position, which is somewhat at variance with the top of the pipe as indicated in figure 1.

Figure 1. Part of the welded steel gas main pipe still in the ditch showing the crack in the weld. A mirror had been placed to the right and near the bottom of the pipe in order to show that part of the crack which extended to the pipe bottom. This photograph was taken looking straight down on the pipe, and was furnished by and used with permission of the Pennsylvania State Police. Approx. X 3/8

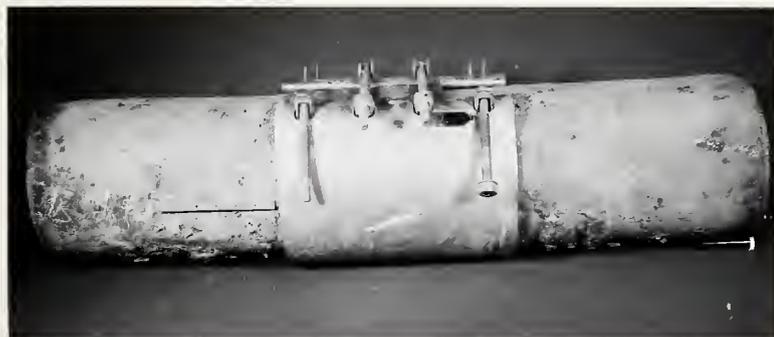
Figure 2. Length of gas pipe containing the cracked weld as received at NBS. The clamp is still in place. X 1/10

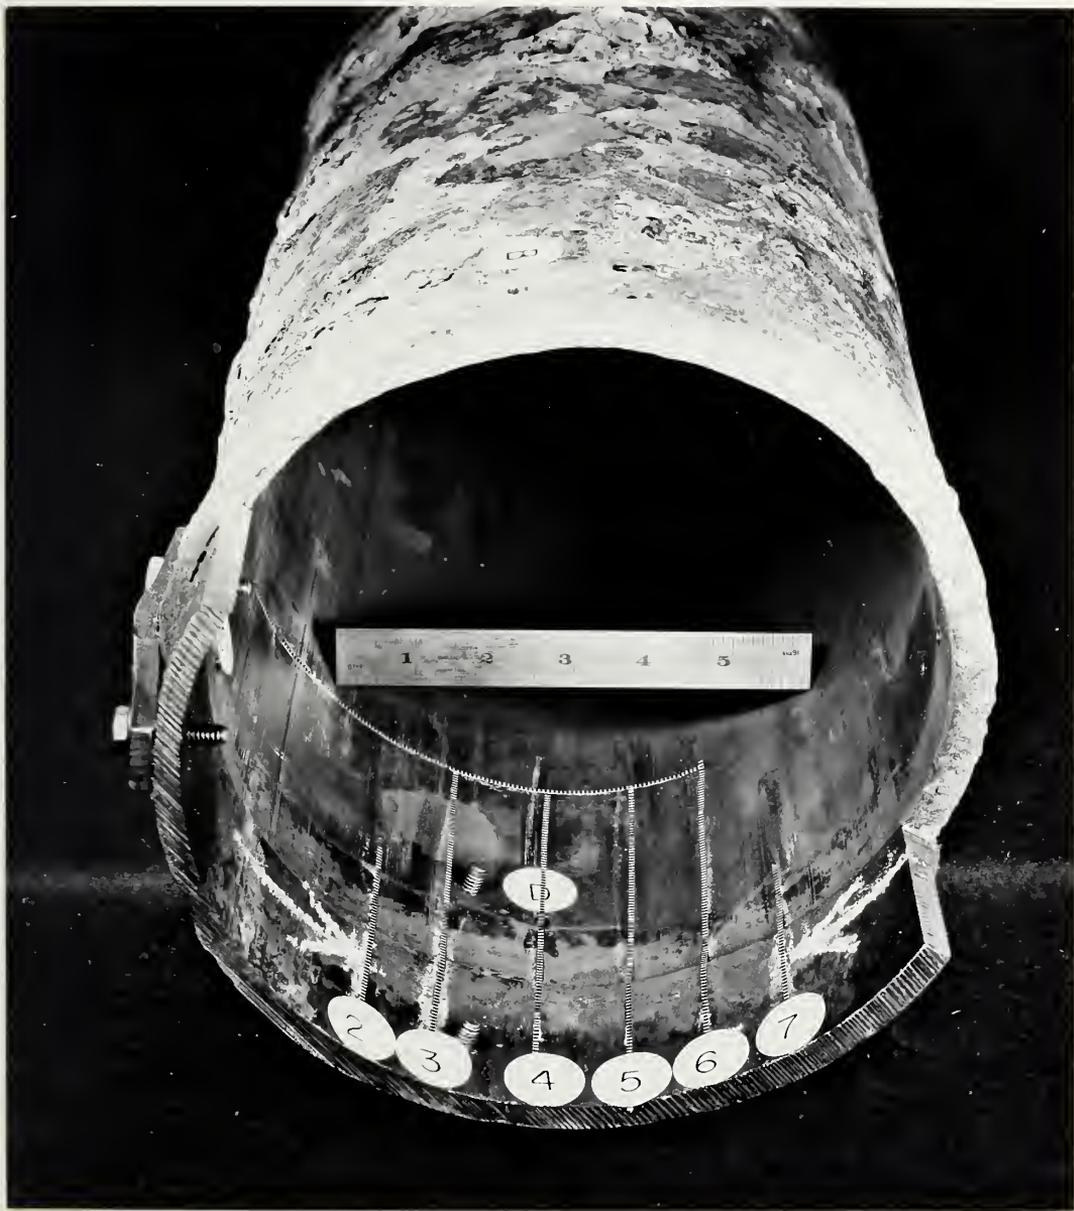
Figure 3a. Part of the pipe length with a portion of the fracture surface exposed. The numbers indicate the locations of specimens referred to in Section 3.3.

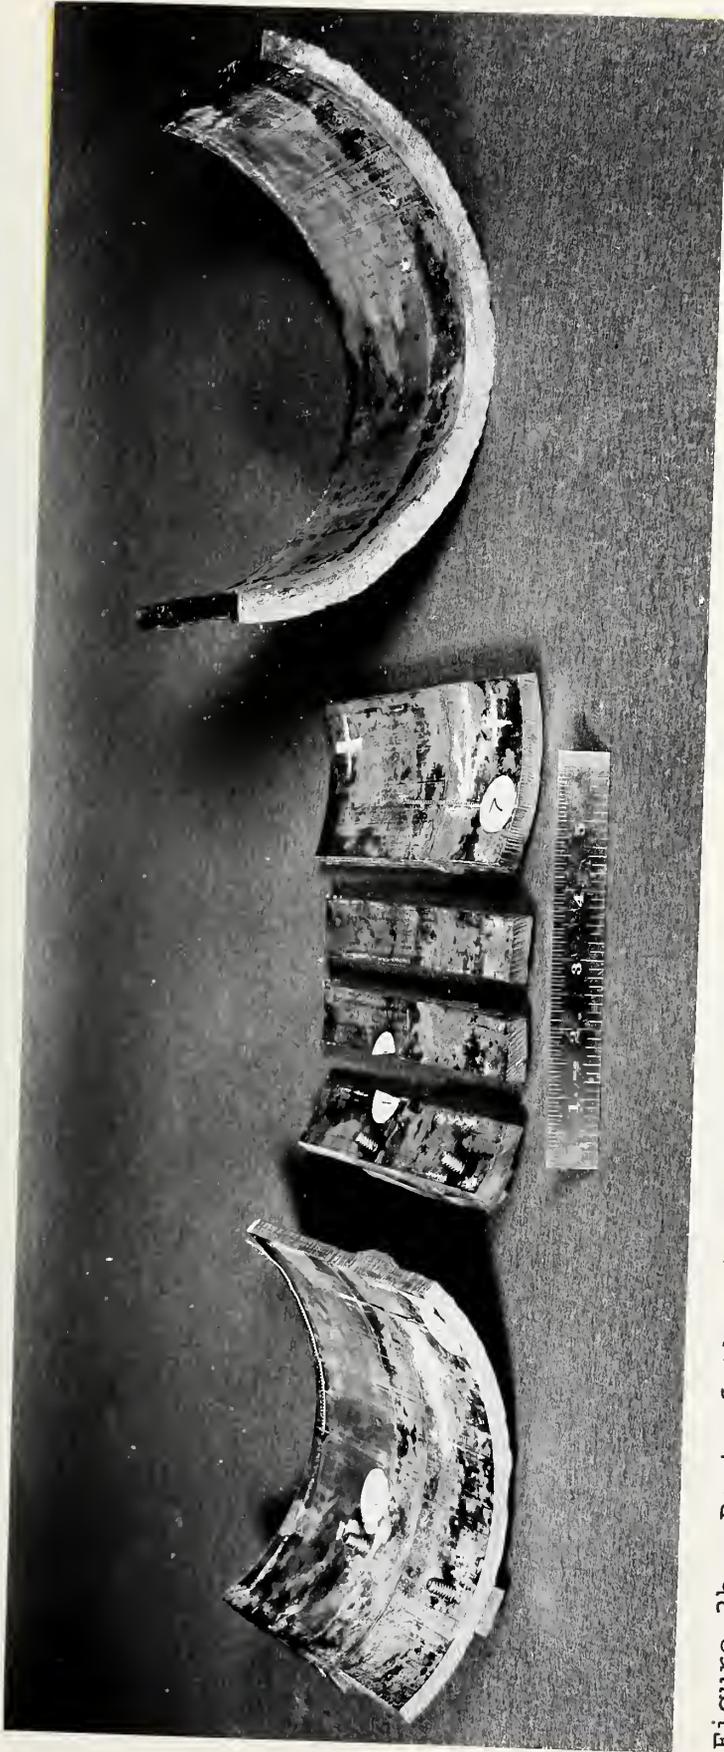
- A. Weld metal pulled to fracture in tension near liquid nitrogen temperature. Specimen had been located between 6 and the end of the tail of the chalk arrow (piece second from the right in figure 3b).
- B. Tensile specimen with reduced section being all weld metal, tested at 70° F. Specimen had been located between 3 and 4 (piece second from the left in figure 3b).
- C. Specimen broken through weld metal in impact at 38° F. Specimen had been located between 2 and 3 (right part of the piece at the far left in figure 3b).
- D. Weld metal pulled to fracture in tension at 35° F. Specimen had been located left of 2 (piece to the far left in figure 3b with the impact specimen removed).

Figure 3b. Part of the pipe showing pieces cut out for mechanical test specimens. The specimen locations are discussed in Section 3.3.

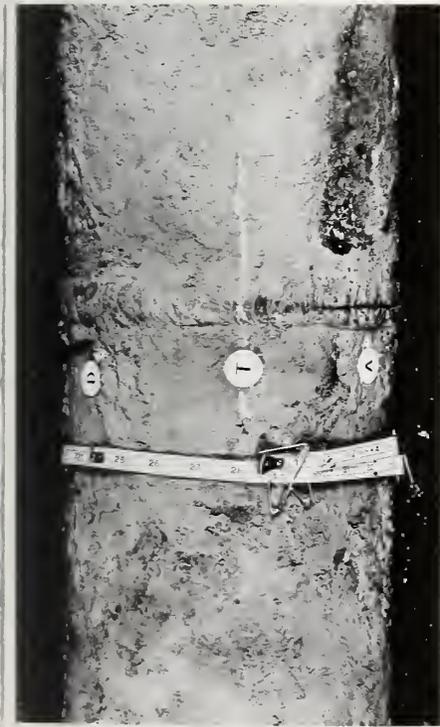
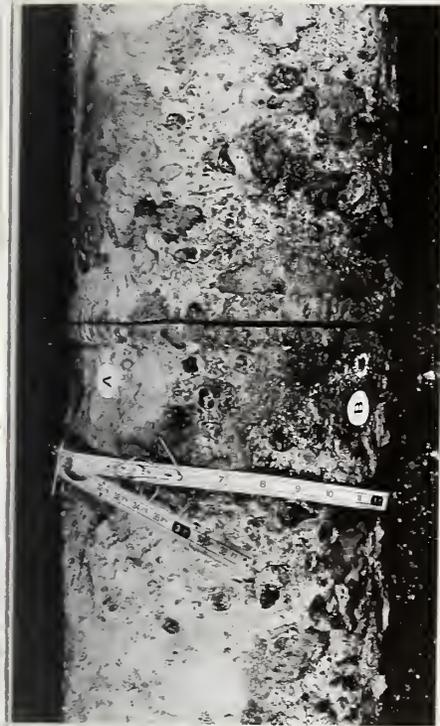
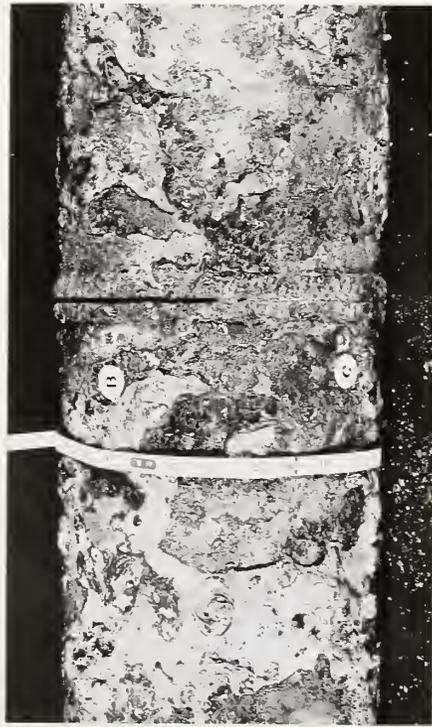
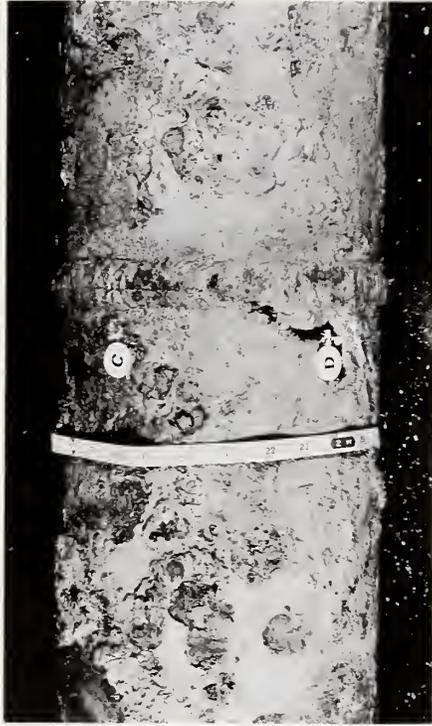
The crack in the weld traversed about two-thirds of the circumference of the pipe. One end of the crack was near the top of the pipe. The length of the crack is indicated in figure 4. This figure shows four views of the pipe in the weld area as seen from the top, both sides, and the bottom with the pipe in the as received condition except for the clamp having been removed. The weld bead around the outside of the pipe appeared to have been made in a single continuous pass while the pipe was rotated. The surface topography of the weld bead appears to be typical of welds made with an oxy-acetylene torch used manually.

Figure 4. Four views of the outside of the pipe in the weld area.

- a. Top
- b. One side
- c. Bottom
- d. Other side

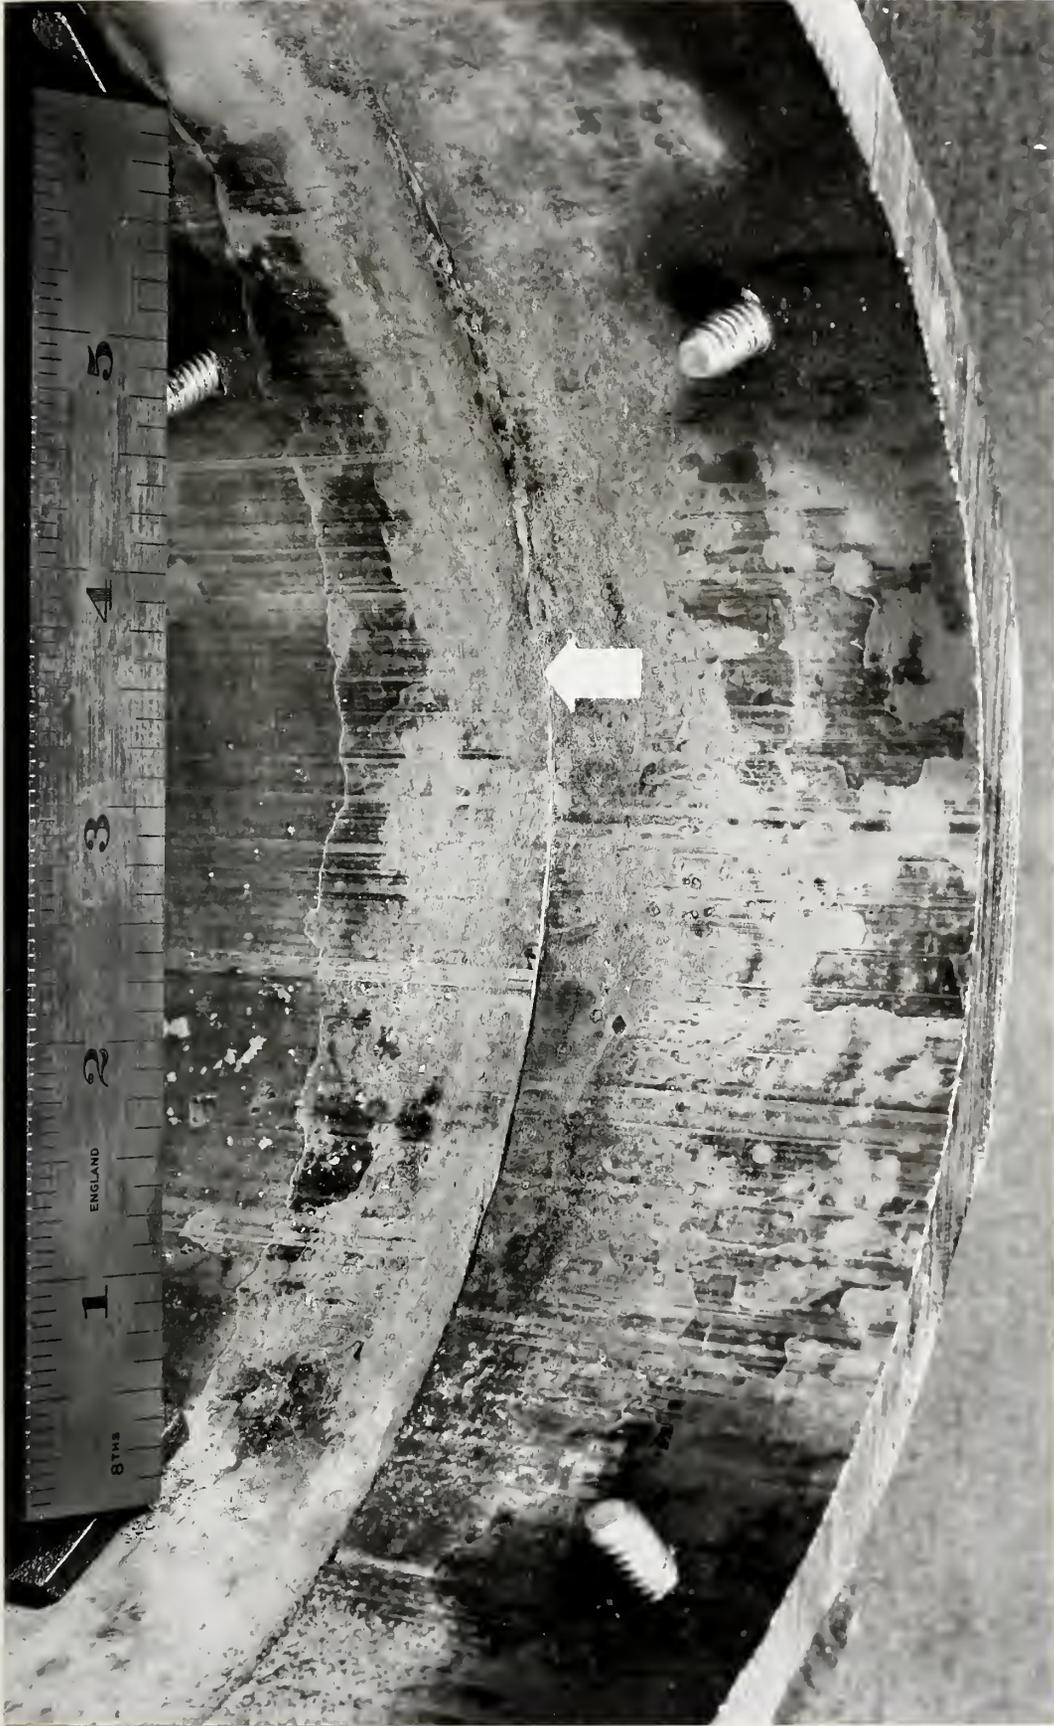
The inside wall surfaces of the pipe had patches of light scale, but in general were relatively clean. There appeared to be somewhat more corrosion product in the region near the weld (probably due to welding flux) than in other areas as can be seen in figure 5. The area shown in this figure contains both cracked and uncracked weld. There is evidence of lack of weld penetration, since over much of the pipe circumference, the weld material does not come through to the inside pipe wall.

Figure 5. Part of the inside wall surface of the pipe in the area of the weld. The weld is cracked to the left of the arrow. The wall surface appears to be more heavily corroded in the area of the weld than in other areas.

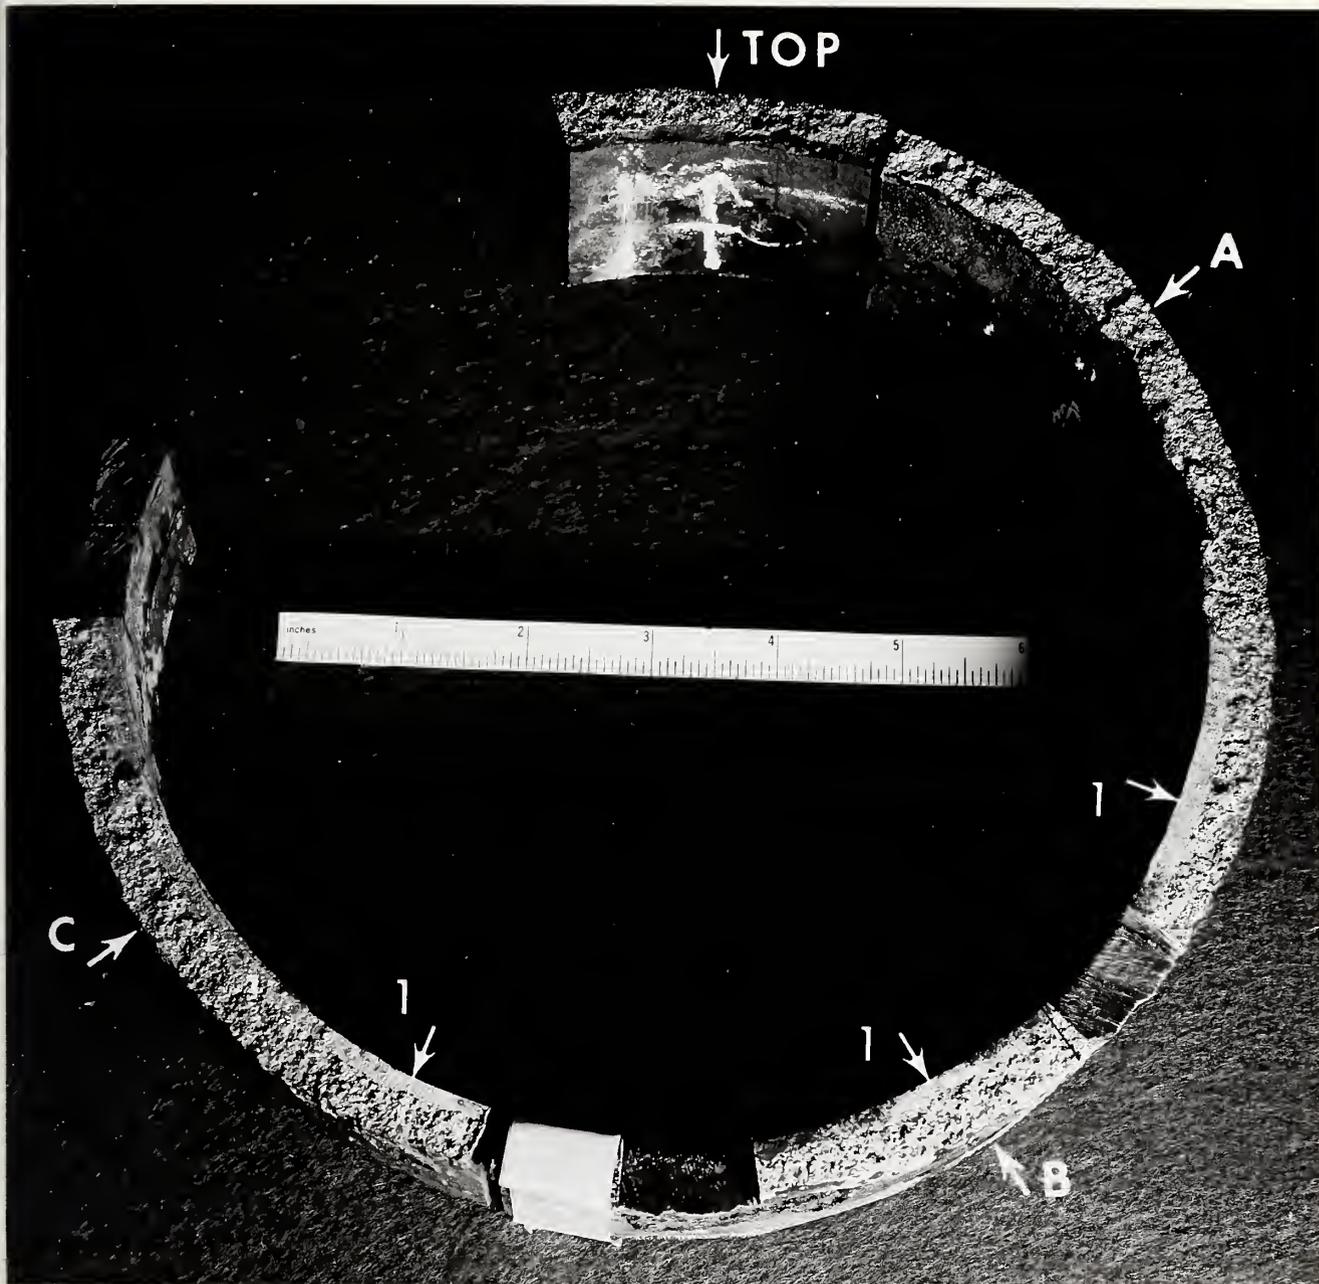
Part of the fracture surface, after being cut from the pipe length, is shown in figure 6. Several specimens had been removed before this photograph was taken. General areas of incomplete weld penetration are indicated by arrows 1. The fracture surface was covered with corrosion product which masked most of the fracture features. There were some spheres of slag on top of the rust which were probably from the oxy-acetylene torch cutting of the pipe section to allow removal from the ditch.

Figure 6. Part of the fracture surface of the pipe with several specimens having been removed. The lettered arrows indicate the same areas as in figure 4. Arrows 1 indicate general areas of incomplete weld penetration (flat areas on the fracture surface adjacent to the inside wall of the pipe).

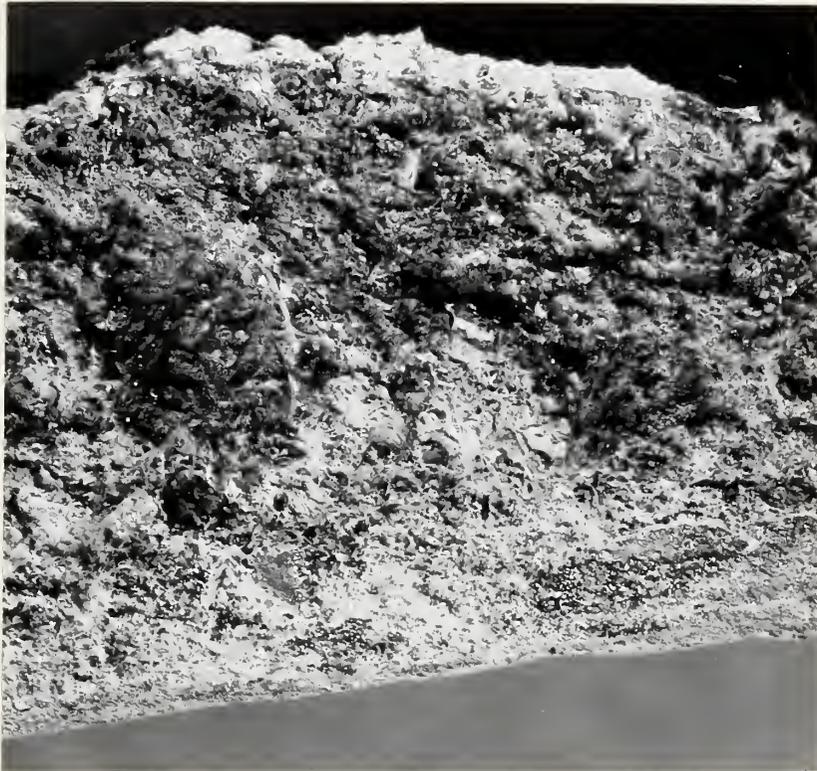
Figure 7. Part of the service fracture surface near one of the crack arrest areas. X 7

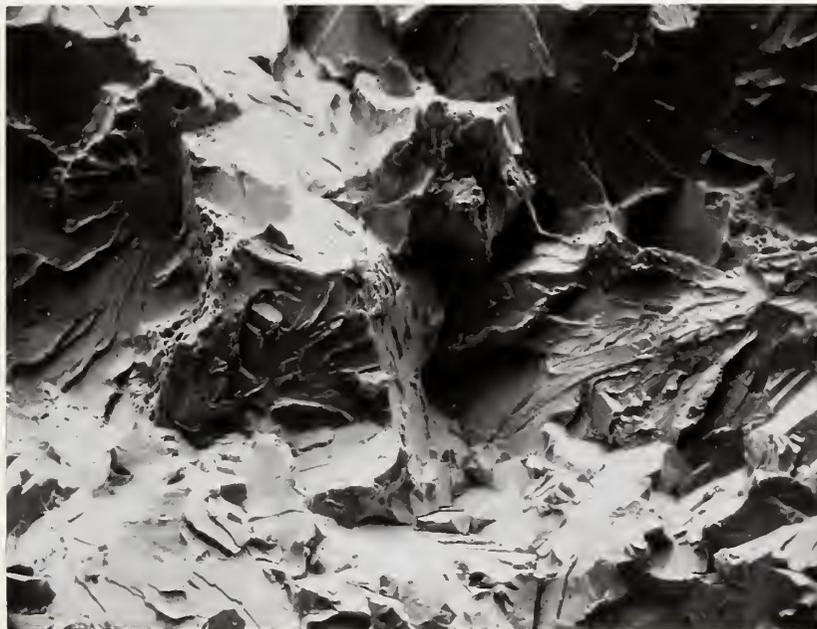
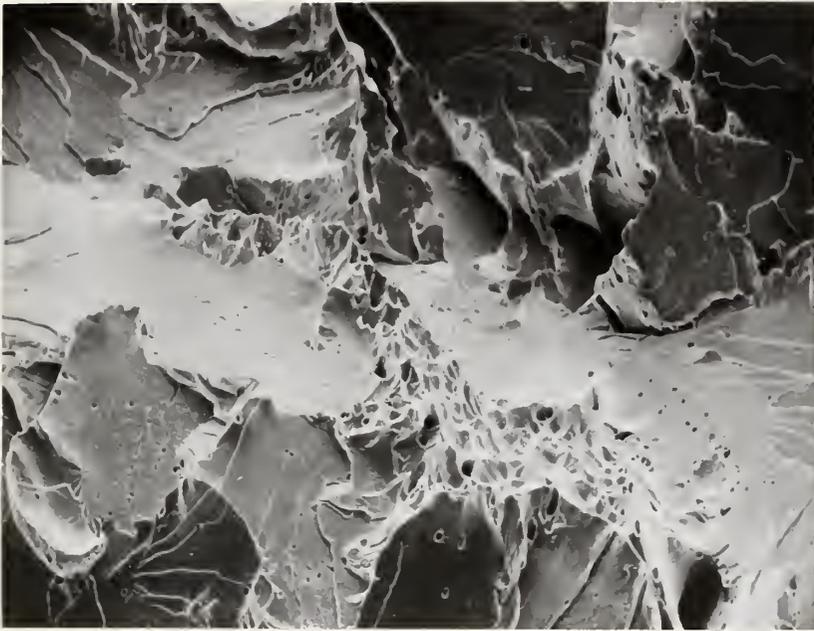
Thus, the fracture appeared to be less ductile near the apparent crack origin than away from the origin. Representative SEM photomicrographs of the service fracture are shown in figures 8 and 9. Quasi-cleavage is the primary fracture feature exhibited, but some dimpled rupture can be seen in both figures.

Figure 8. SEM photomicrograph of service fracture surface showing primarily quasi-cleavage and some dimpled rupture. X 105

Figure 9. SEM photomicrograph of service fracture surface showing primarily quasi-cleavage and some dimpled rupture. X 250

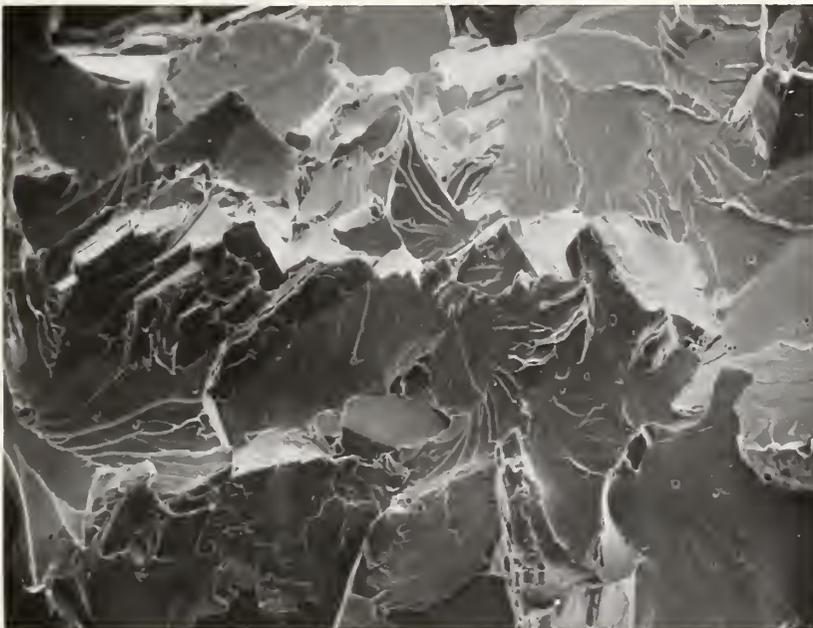
The fracture surface produced by extending the service crack through weld metal under a tensile load at near liquid nitrogen temperature exhibited quasi-cleavage as essentially the only fracture feature, indicating a completely brittle fracture. An SEM photomicrograph representative of this fracture surface is shown in figure 10.

Figure 10. SEM photomicrograph of fracture surface of weld material pulled in tension after cooling in liquid nitrogen. Quasi-cleavage is essentially the only fracture feature exhibited. X 250

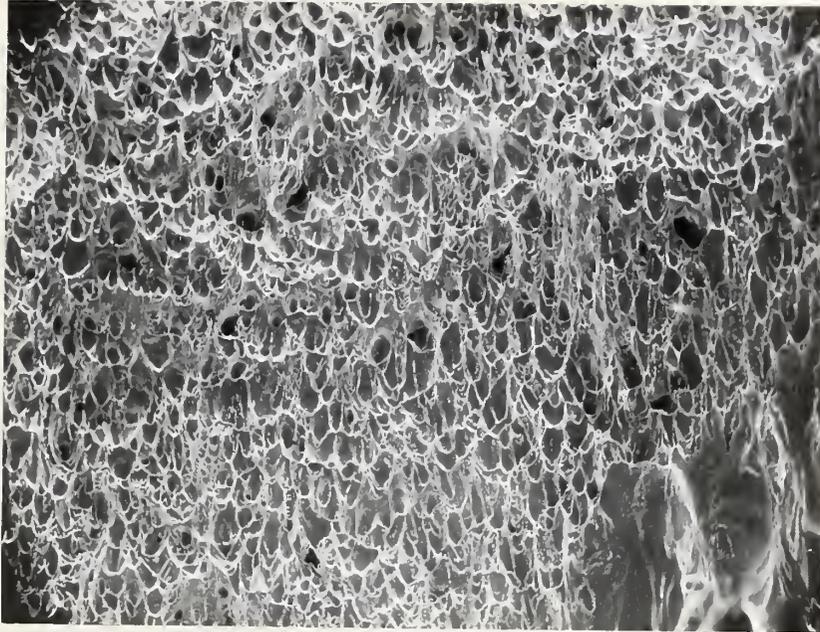
The fracture surface of the tensile specimen with an all weld metal reduced cross section exhibited essentially all dimpled rupture indicating a ductile fracture. The specimen had an ultimate tensile strength of about 50,800 psi and an apparent elongation in 2 inches of 5 percent. Since one face of the specimen had been curved to a radius of 3.5 inches to eliminate voids in the root of the weld and to assure fracture through the weld, the true elongation was somewhat greater than 5 percent. This amount of elongation indicates that the weld metal was ductile, which agrees with the results of the fractographic examination. An SEM photomicrograph showing a representative area of the tensile specimen fracture surface is shown in figure 11.

Figure 11. SEM photomicrograph of fracture surface of tensile specimen failed through weld metal at 70° F. Dimpled rupture is essentially the only fracture feature exhibited. X 140

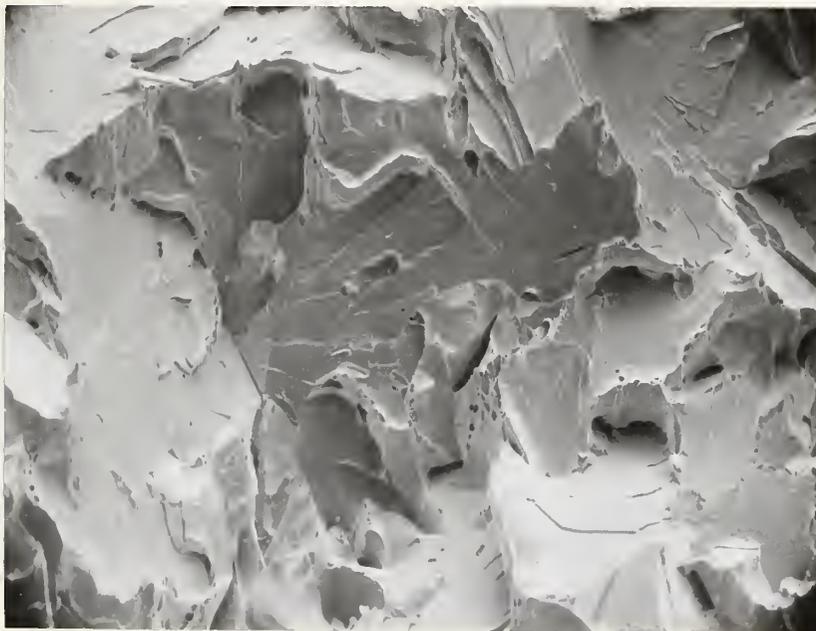
The fracture surface of the specimen fractured in impact through weld metal at 38° F exhibited 6 percent dimpled rupture, the remainder being quasi-cleavage. A representative area of this specimen fracture surface is shown in figure 12.

Figure 12. SEM photomicrograph of fracture surface of impact specimen tested at 38° F showing primarily quasi-cleavage and a small amount of dimpled rupture. X 135

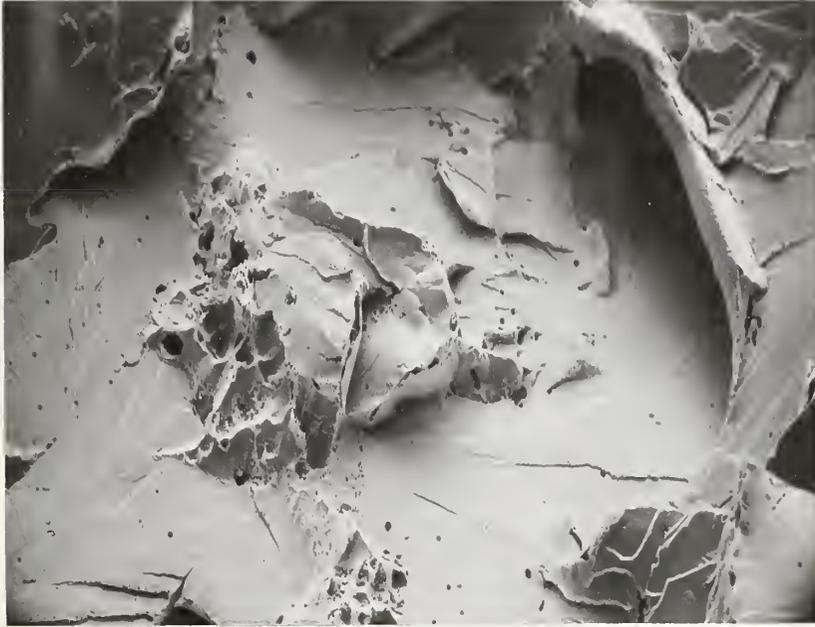
The fracture surface produced by extending the service crack under tensile loading at 35° F exhibited 11 percent dimpled rupture compared to 9 percent dimpled rupture for the service crack adjacent to it. The remainder of the fracture features at each point exhibited quasi-cleavage, indicating that the fracture was primarily of a brittle nature. A representative area of this fracture surface is shown in figure 13.

Figure 13. SEM photomicrograph of fracture surface of weld metal pulled in tension at 35° F. Quasi-cleavage is the primary fracture feature exhibited, but there is some dimpled rupture. X 190

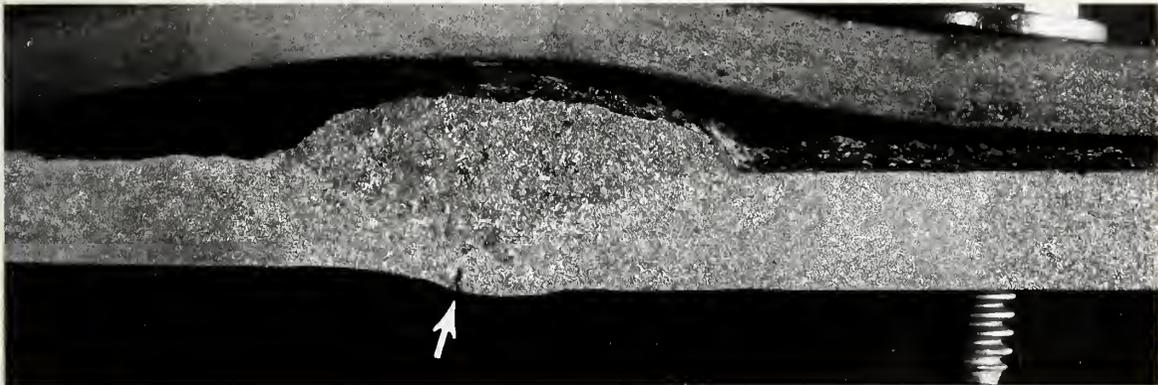
A longitudinal side of the tensile specimen tested at 70° F was prepared metallographically before the test was conducted. A low magnification view of this in the etched condition (figure 14) indicates that the weld was made in one pass. There is a small amount of mismatch between the two pieces of pipe at this point, as the planes of the wall surfaces of one piece do not quite coincide with the corresponding planes of the wall surfaces of the other piece.

Figure 14. Etched longitudinal side of tensile specimen encompassing the weld before testing. Lack of penetration is indicated by the arrow. The weld appears to have been made in a single pass. Etch: 20% nitric acid in water. X 2

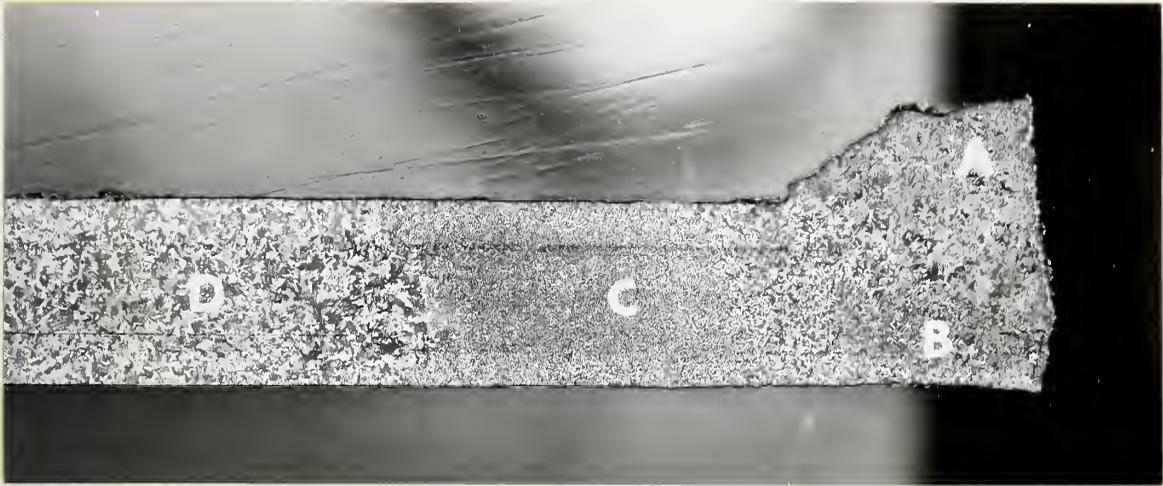
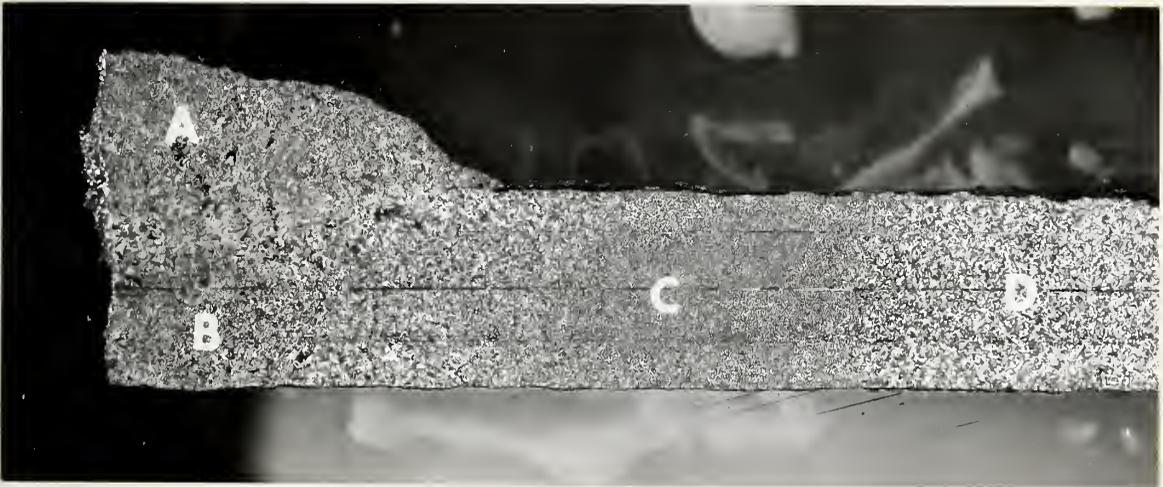
Longitudinal sections through both pieces of pipe intersecting the fracture surface are shown in figure 15. The microstructure of the weld material (area A) is similar for both pieces and consists of a ferrite matrix in a Widmanstätten pattern with a little cementite and some pearlite in the grain boundaries. A representative area of the weld material is shown in figure 16. The microstructure of the pipe material adjacent to the weld (area B), again similar for both pieces, is shown in figure 17. The microstructure appears to have undergone phase transformation (austenite to ferrite) as a result of heating during welding. It consists of a ferrite matrix with some cementite and pearlite in the grain boundaries. The heat affected zones (area C, figure 15) on both sides of the weld exhibit similar microstructures. A representative area is shown in figure 18. This microstructure, consisting of small grains of ferrite and some pearlite and cementite in the grain boundaries, appears to have been heated into the lower part of the ferrite plus austenite temperature range. There were some differences between the microstructures of the two pieces of pipe in area D (fig. 15) just beyond the heat affected zones. In both cases, ferrite is the primary constituent with some pearlite and cementite in the grain boundaries, but one exhibits a Widmanstätten structure and the other does not. Examples of these microstructures are shown in figure 19.

Figure 15. Etched longitudinal sections through pieces of pipe on either side of the weld. The sections intersect the fracture. Letter designations are as follows:

- A. Weld material.
- B. Pipe material adjacent to the weld in the heat affected zone.
- C. Heat affected zone somewhat removed from the weld.
- D. Parent pipe material.

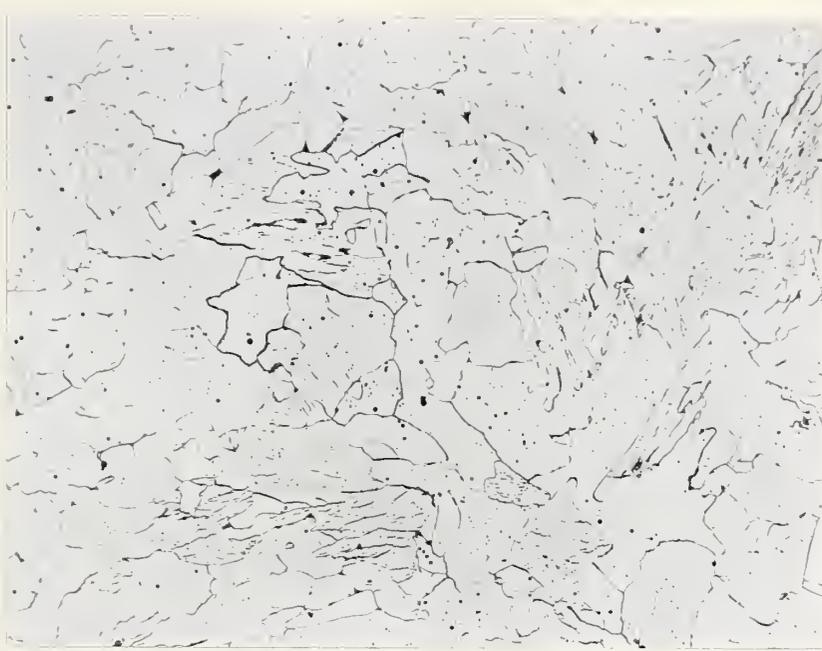
Figure 16. Etched microstructure of longitudinal section through weld. Microstructure consists primarily of ferrite, some of which is in a Widmanstätten pattern, with some cementite and pearlite in the grain boundaries. Etch: 1% nital. X 100

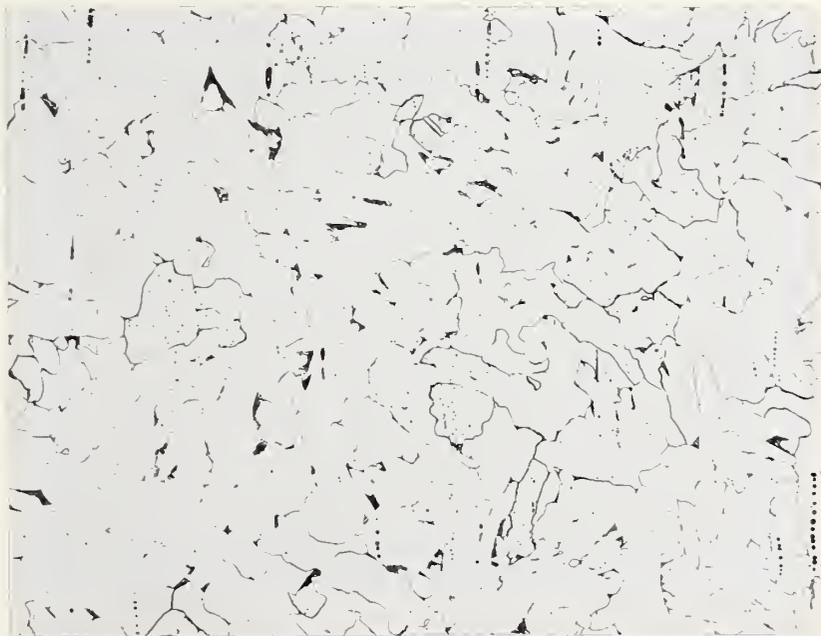
Figure 17. Etched microstructure of longitudinal section through pipe material adjacent to the weld. Microstructure consists of ferrite with some cementite and pearlite in the grain boundaries. A phase transformation has taken place. Etch: 1% nital. X 100

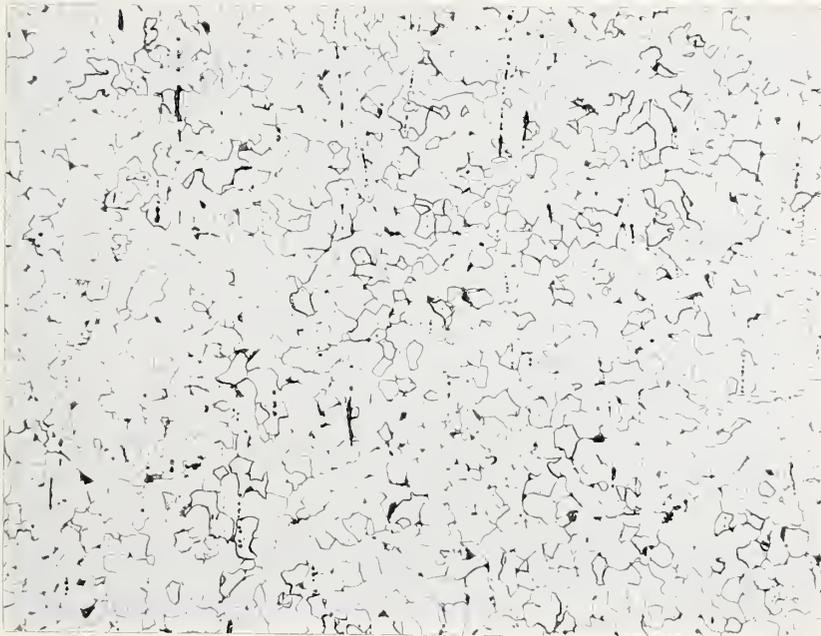
Figure 18. Representative etched area of longitudinal section through heat affected zone. Microstructure consists of ferrite and some pearlite and cementite in the grain boundaries.  
Etch: 1% nital. X 100

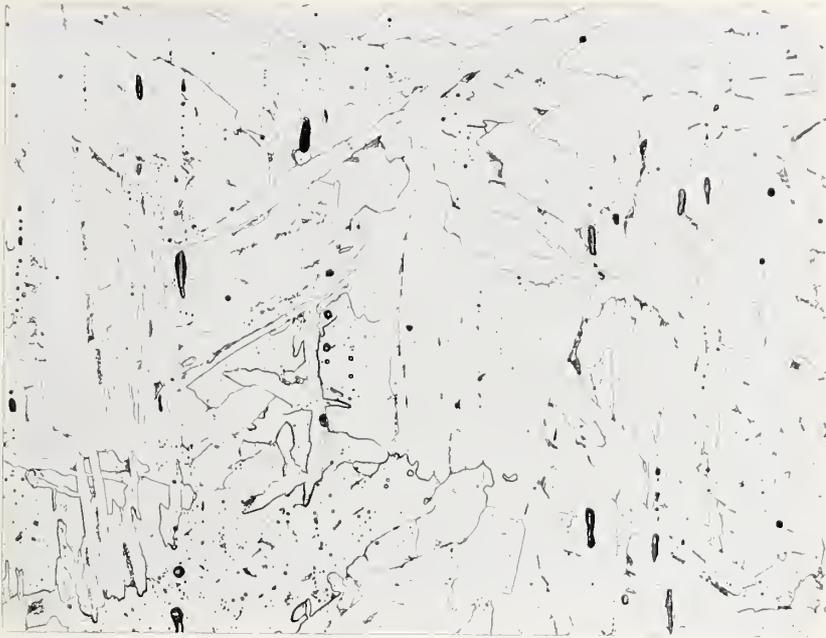
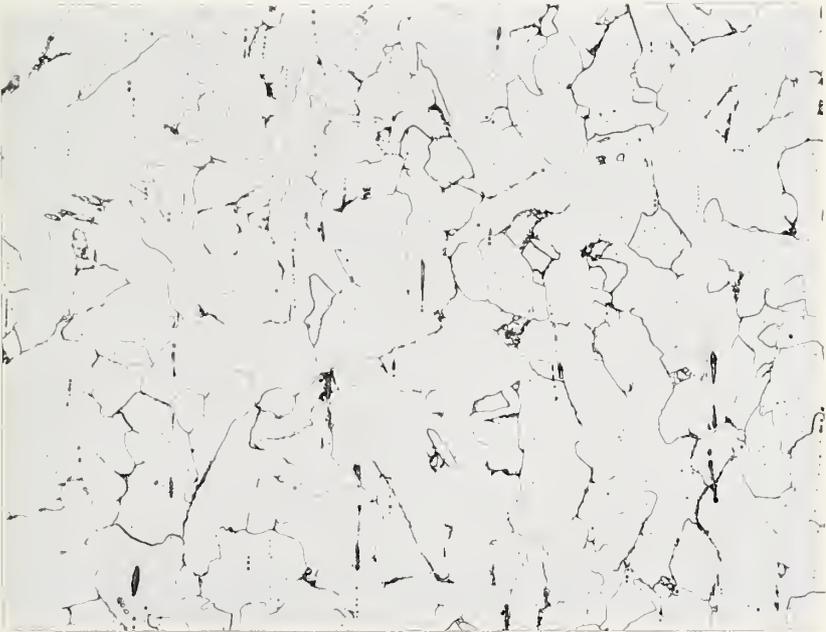
Figure 19. Etched longitudinal sections through both pieces of pipe adjacent to the heat affected zone. In both cases, the microstructure consists primarily of ferrite with some pearlite and cementite in the grain boundaries. In figure 19a, some Widmanstätten structure can be seen.  
Etch: 1% nital. X 100

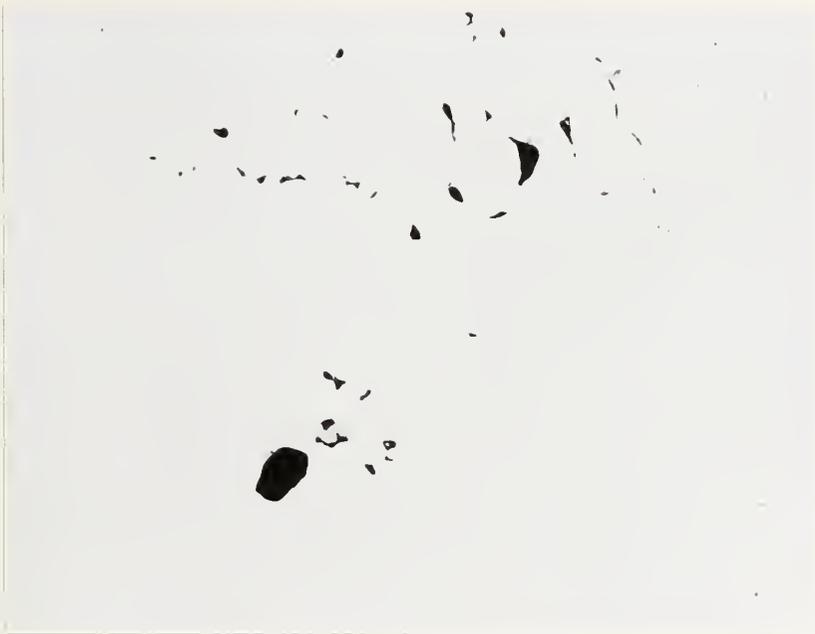
Figure 20. Unetched longitudinal sections through weld material. X 100

- a. Area containing more than average porosity.
- b. Area representative of the weld material.

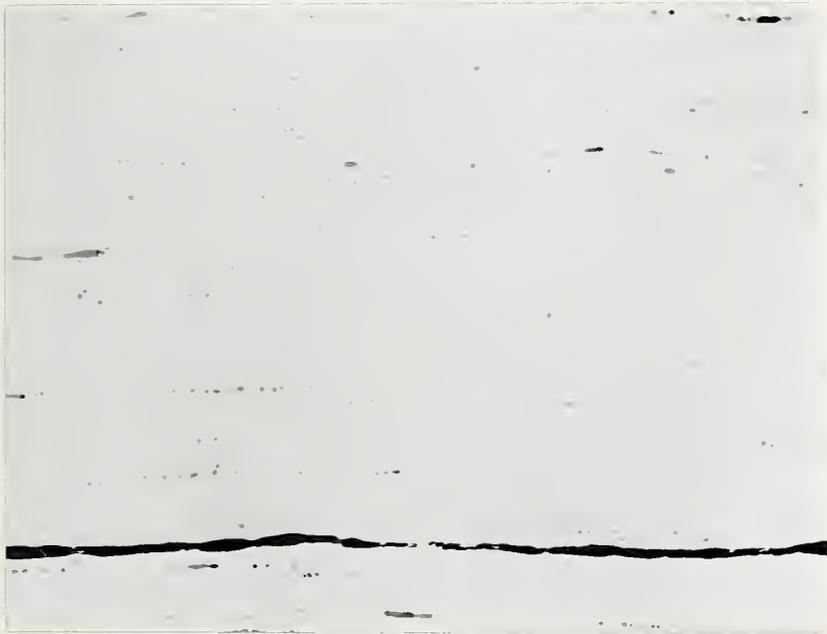
Figure 21. Unetched longitudinal section through pipe material showing the inclusion content. X 100
